# CHURCH OF THE HOLY SEPULCHRE JERUSALEM

STRUCTURAL SURVEY  
FINAL REPORT

WILLIAM HARVEY

1935

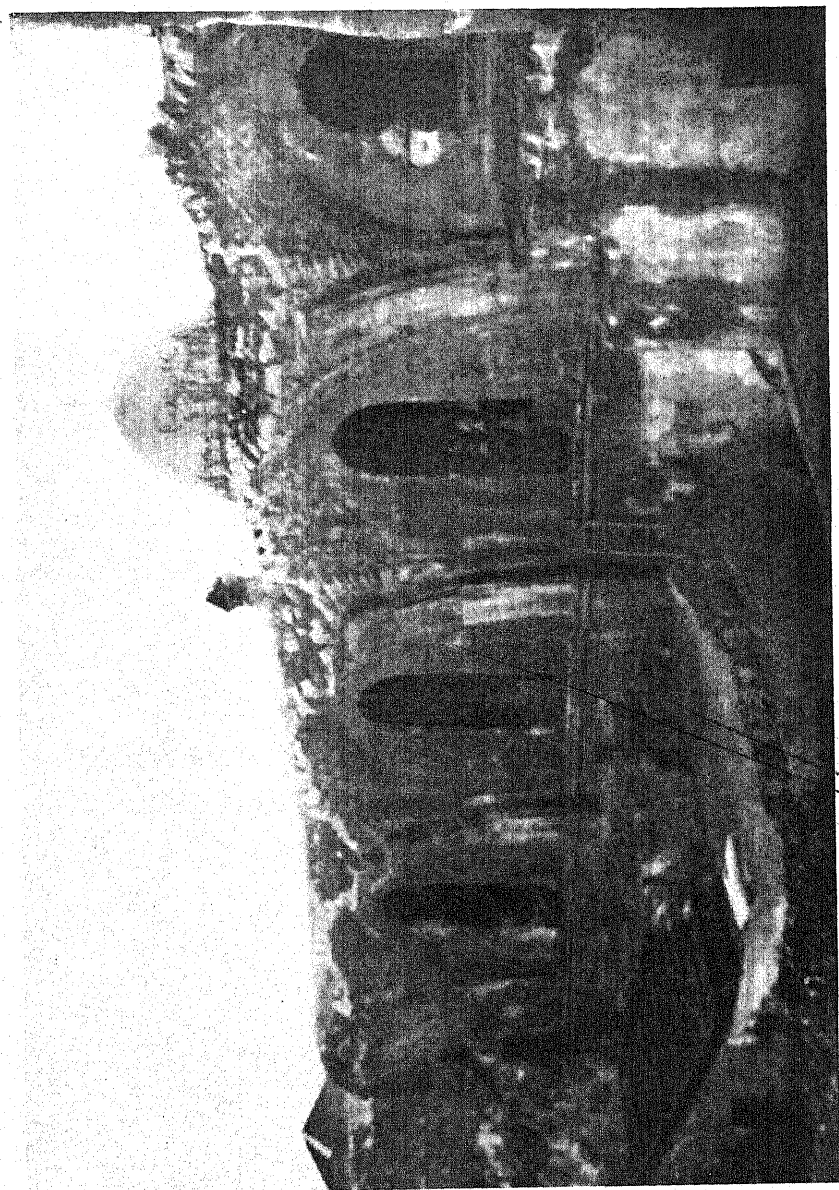
Secondly, the major part of the South wall of the old Latin Refectory (see Figs. 70, 71, II, 14) is in a ruined state, with large masses of overhanging vaulting. These are cracking away from the wall, and there is grave danger of their collapse.

FIG. 70. RUINED SOUTH WALL OF OLD REFECTORY

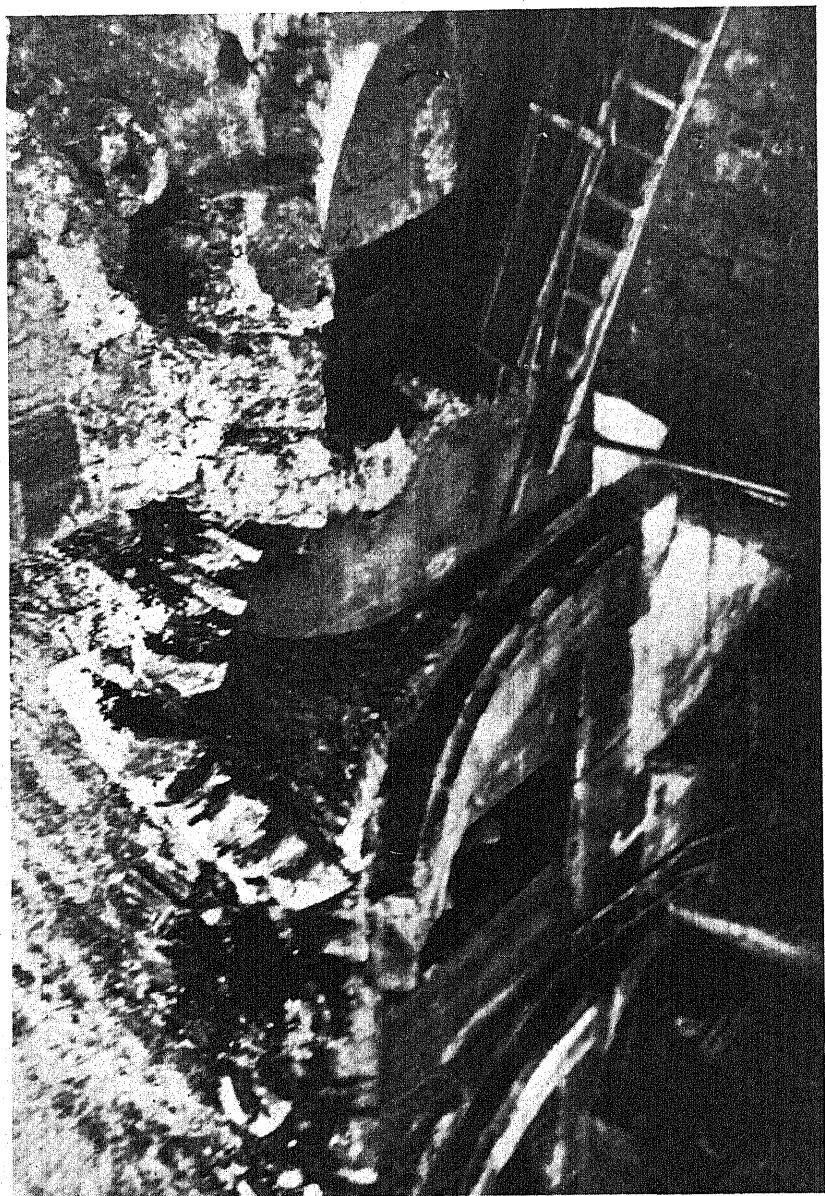
FIG. 71. OVERHANGING VAULT MASSES OF OLD REFECTORY

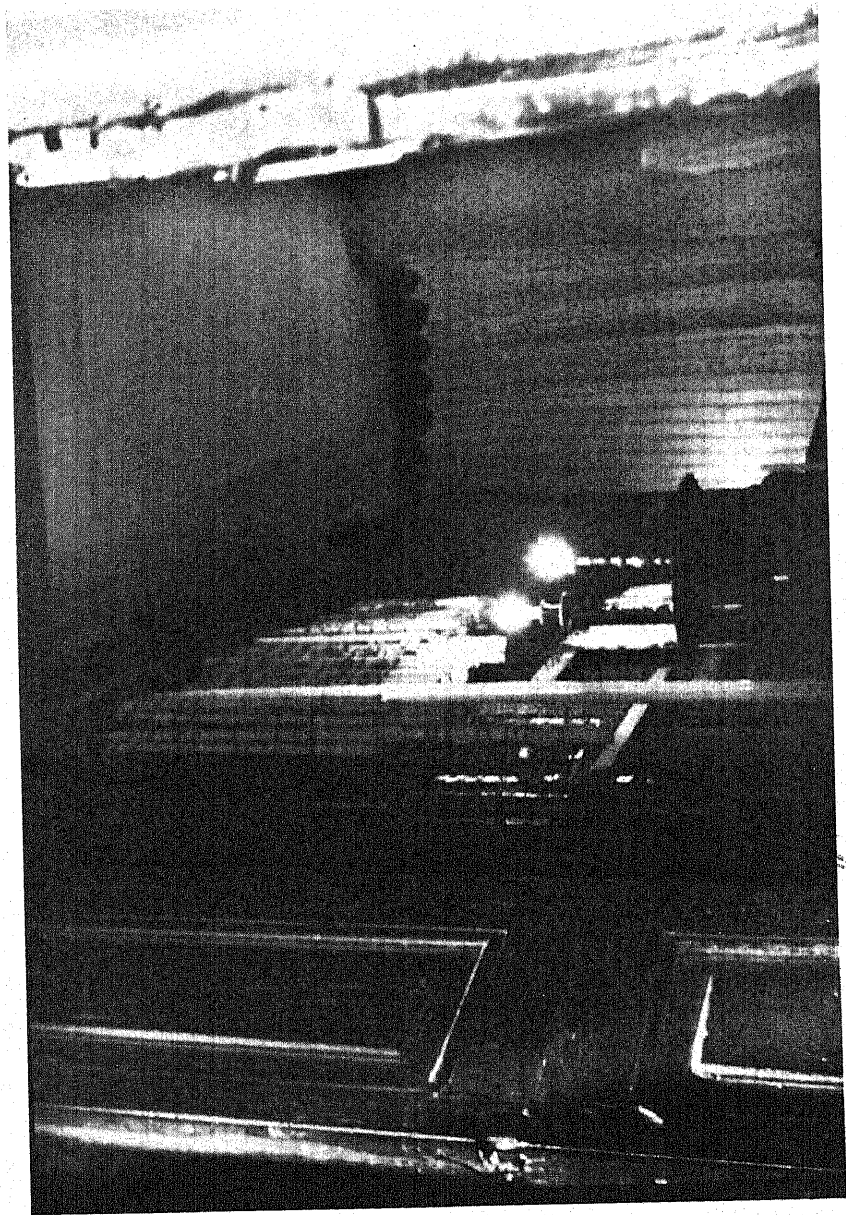
produce another such conflagration. Many of the small rooms which have been formed in the aisle of the Rotunda (see Figs. 72, I, 23) are used as stores for miscellaneous property, including large quantities of candles and oil. As there is much dry and decaying timber adjacent, a fire could easily be started, especially as only open lamps and candles are used for light in these rooms.

FIG. 72. CANDLE STORE IN OLD AISLE OF ROTUNDA

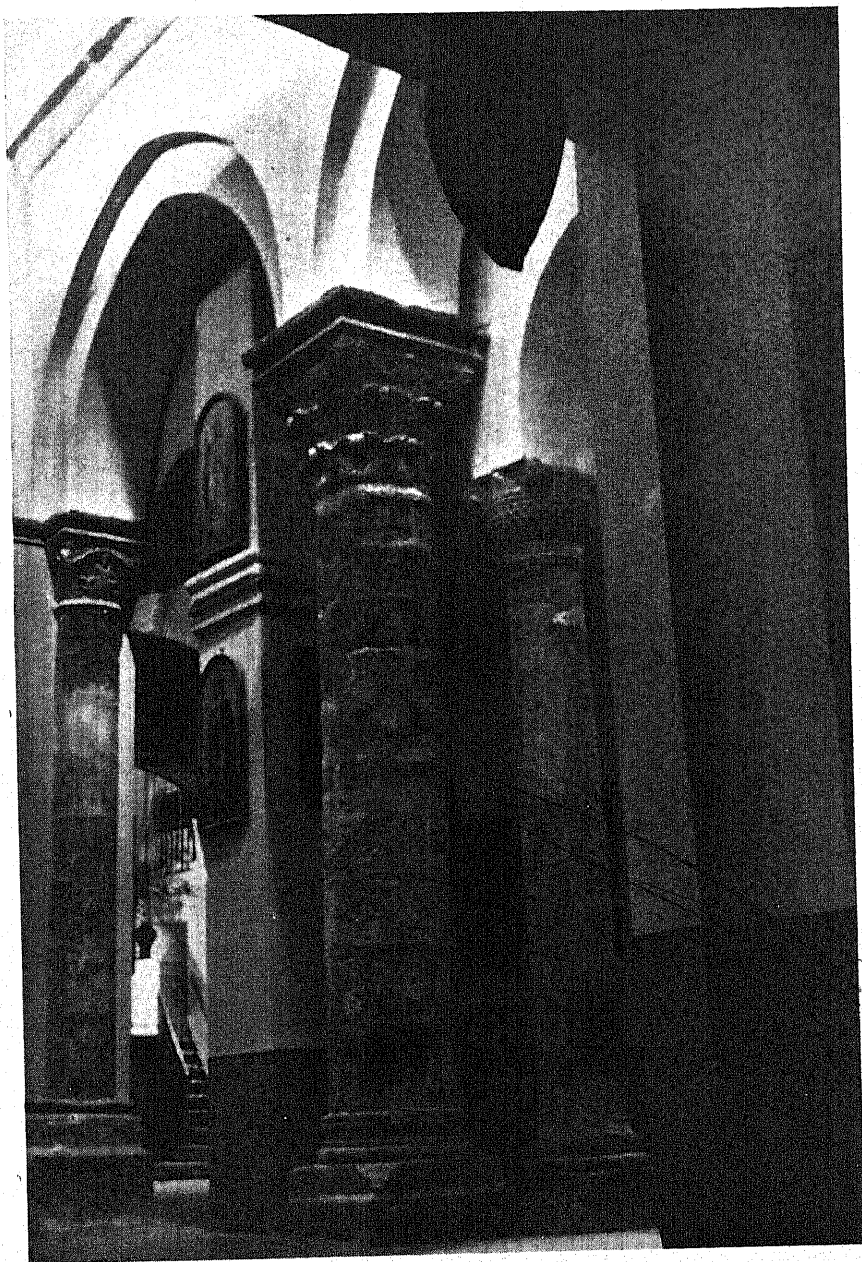
FIG. 73. PIERS OF NORTH TRANSEPT, SHOWING  
MASONRY AND PLASTERED FACES

(1) An alteration which would affect the whole Church, though without changing the present arrangement, would be the stripping off of all plasterwork, thus revealing the original stone faces, which would then be carefully washed. As very large portions of the plasterwork would in any case be removed during the work of repair, this would involve little extra labour, and would greatly improve the appearance of the interior. Special care would have to be taken to ensure that any traces of original mosaic or colouring would be preserved (see Figs. 73, 74, 75).

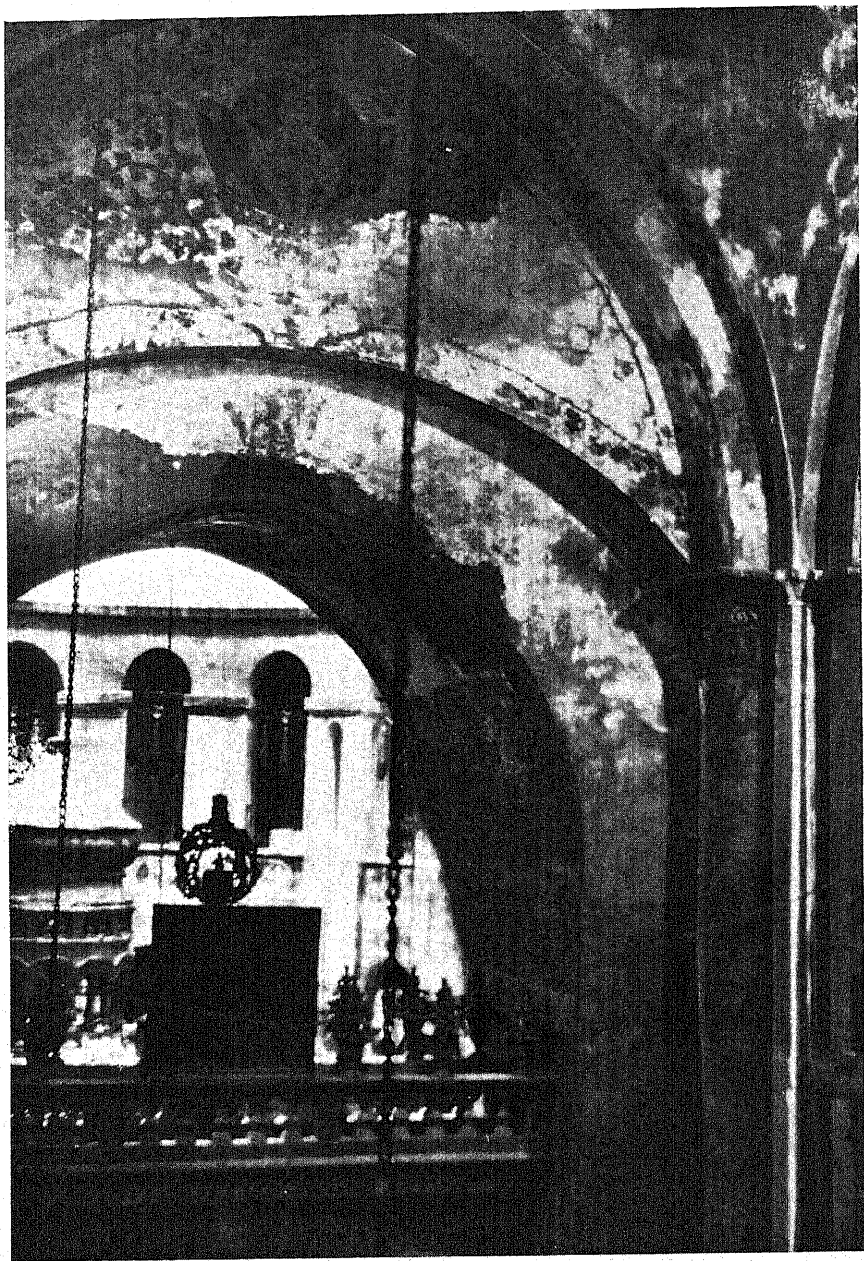
FIG. 74. GREAT ARCH OF ROTUNDA, SHOWING PLASTERING  
OF 1810 CONCEALING CARVED WORK

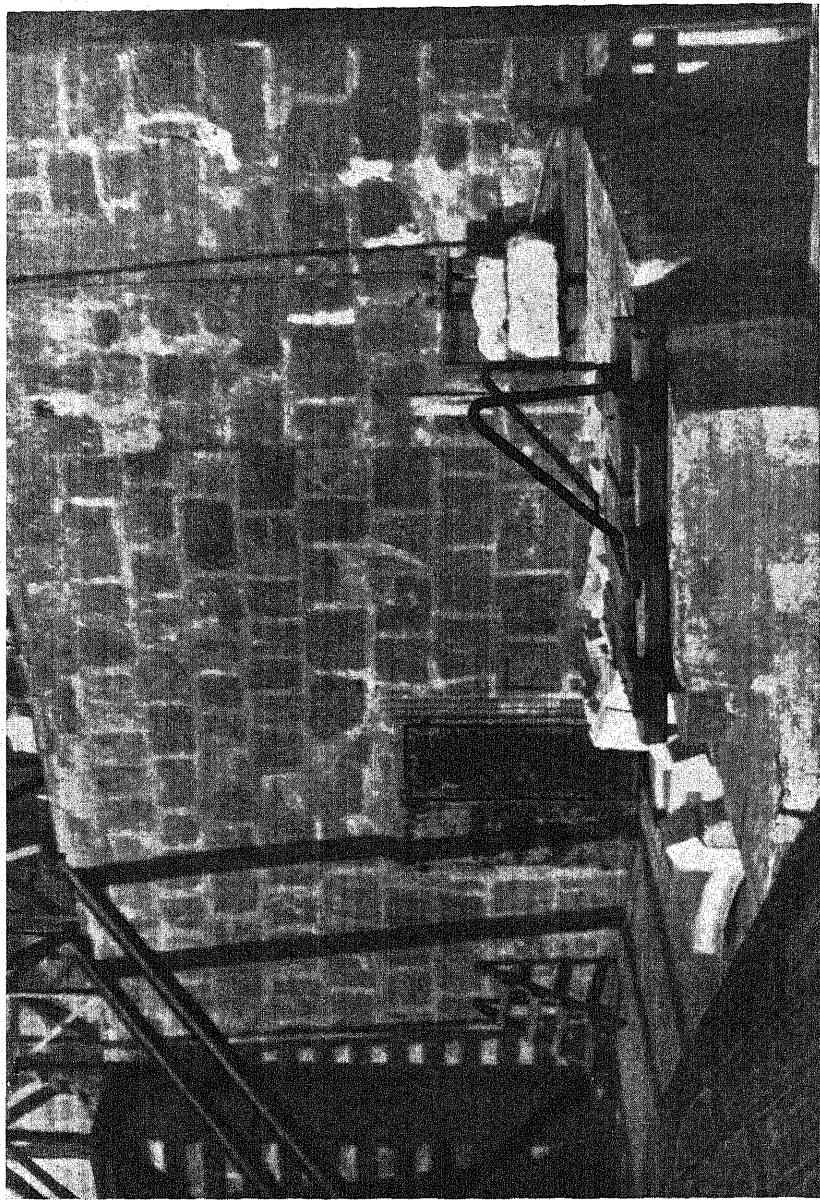
FIG. 76. WINDOW BLOCKED BY IRON DOORS

1. High vault North Transept West wall (1).
2. High vault East arm South wall (1) (see Fig. 76).
3. Ambulatory North-east apsidal chapel (2) (see Fig. 77).
4. Ambulatory centre apsidal chapel (3) (see Fig. 78).
5. Above stair to St. Helena's Chapel (1).
6. Ambulatory South-east apsidal chapel (2).

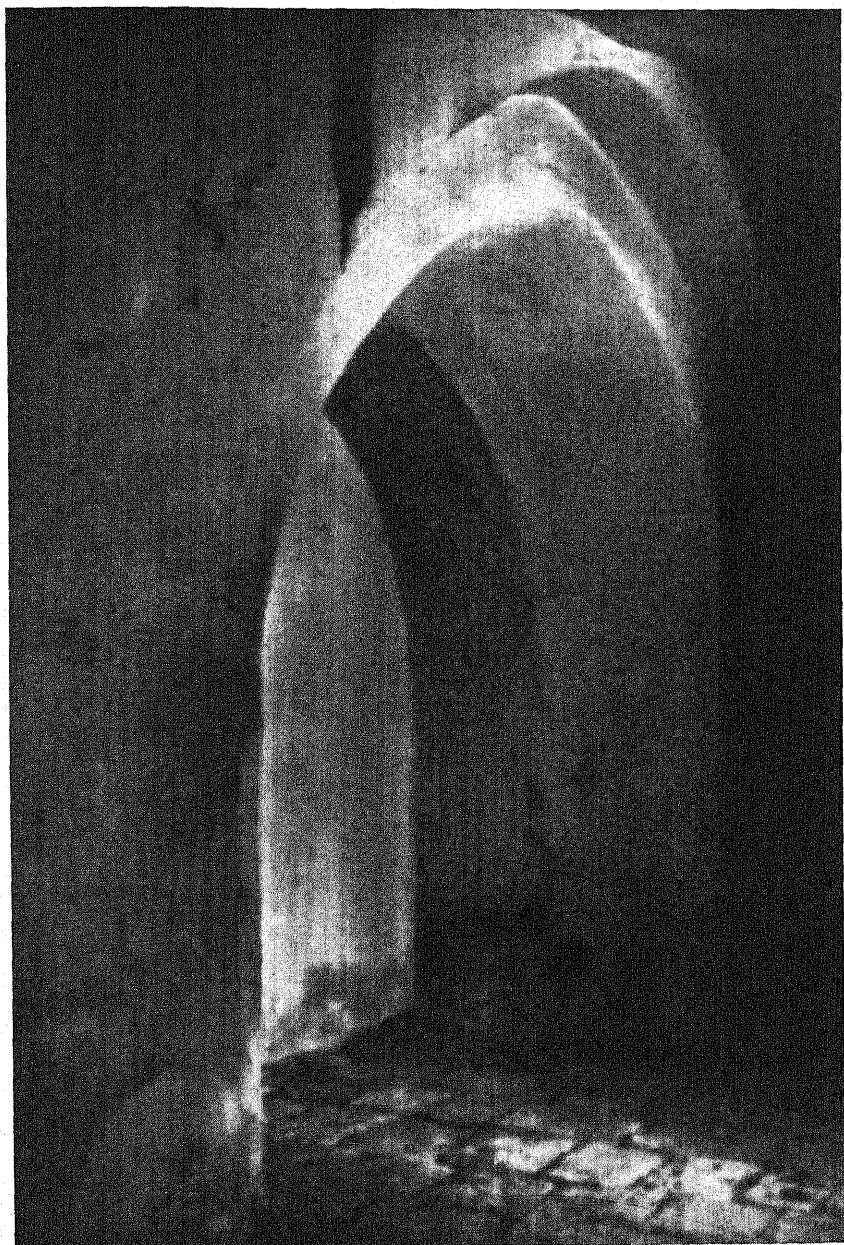
FIG. 77. BLOCKED WINDOW OF AMBULATORY

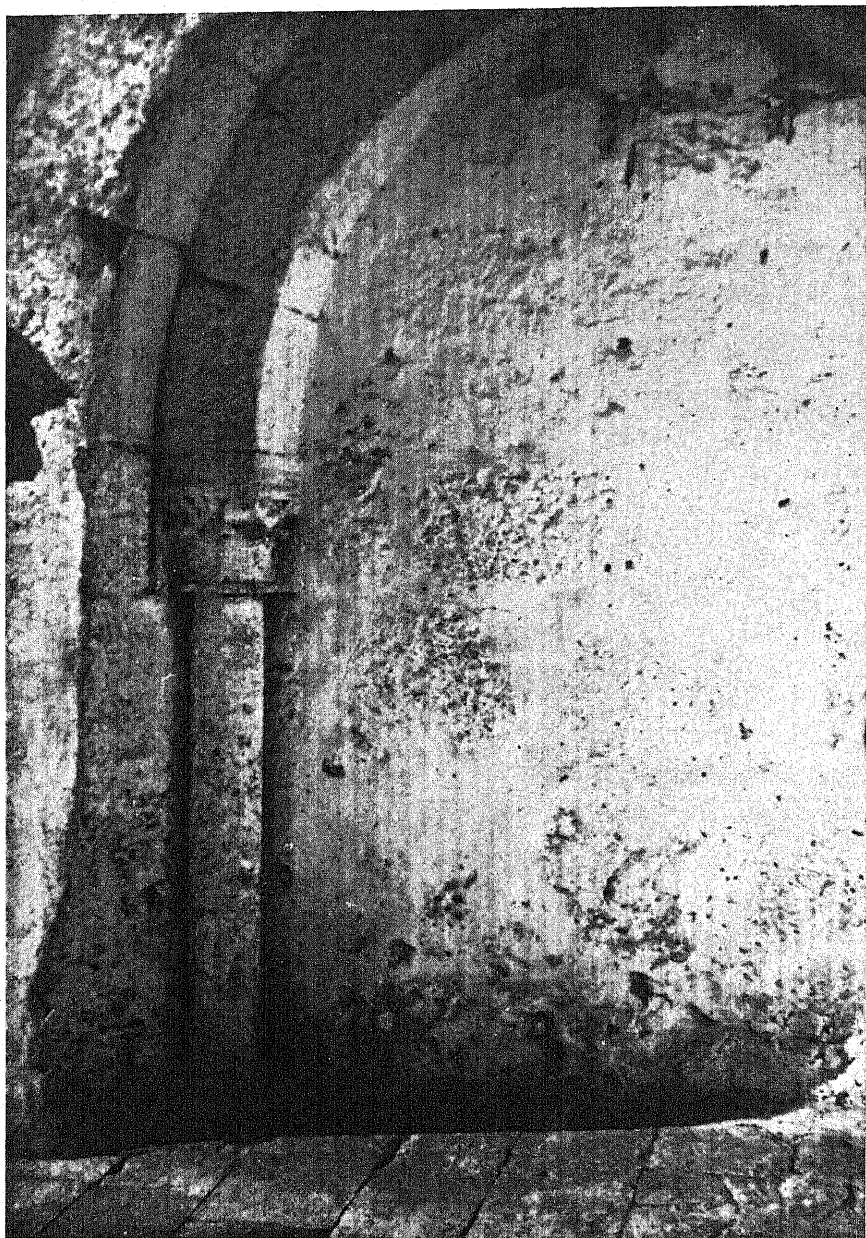
FIG. 78. BLOCKED WINDOW OF CENTRAL APSE CHAPEL

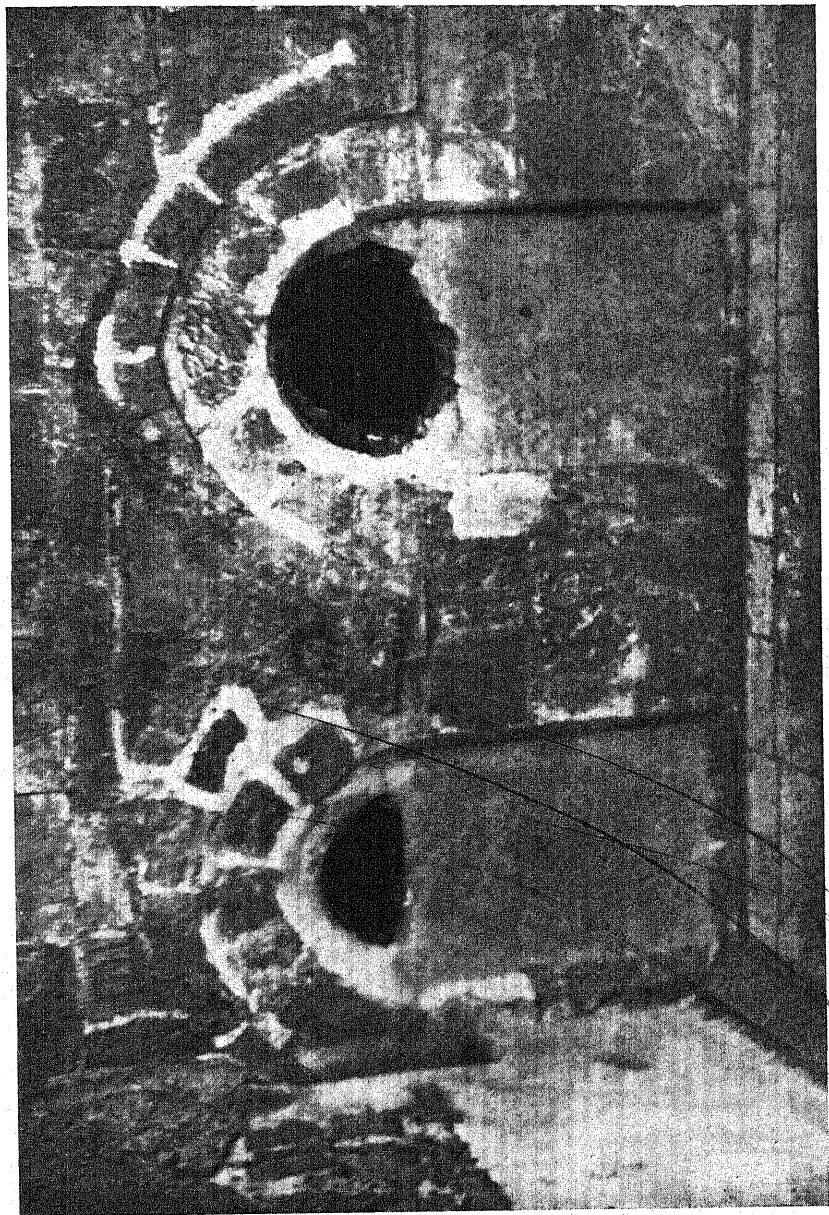
FIG. 79. PARTIALLY BLOCKED WINDOWS OF NORTH TRANSEPT

1. High vault North Transept North wall (2) (see Fig. 79).
2. High vault East arm North wall (1).
3. Eastern arm North wall—to Latin chamber (shuttered) (2).

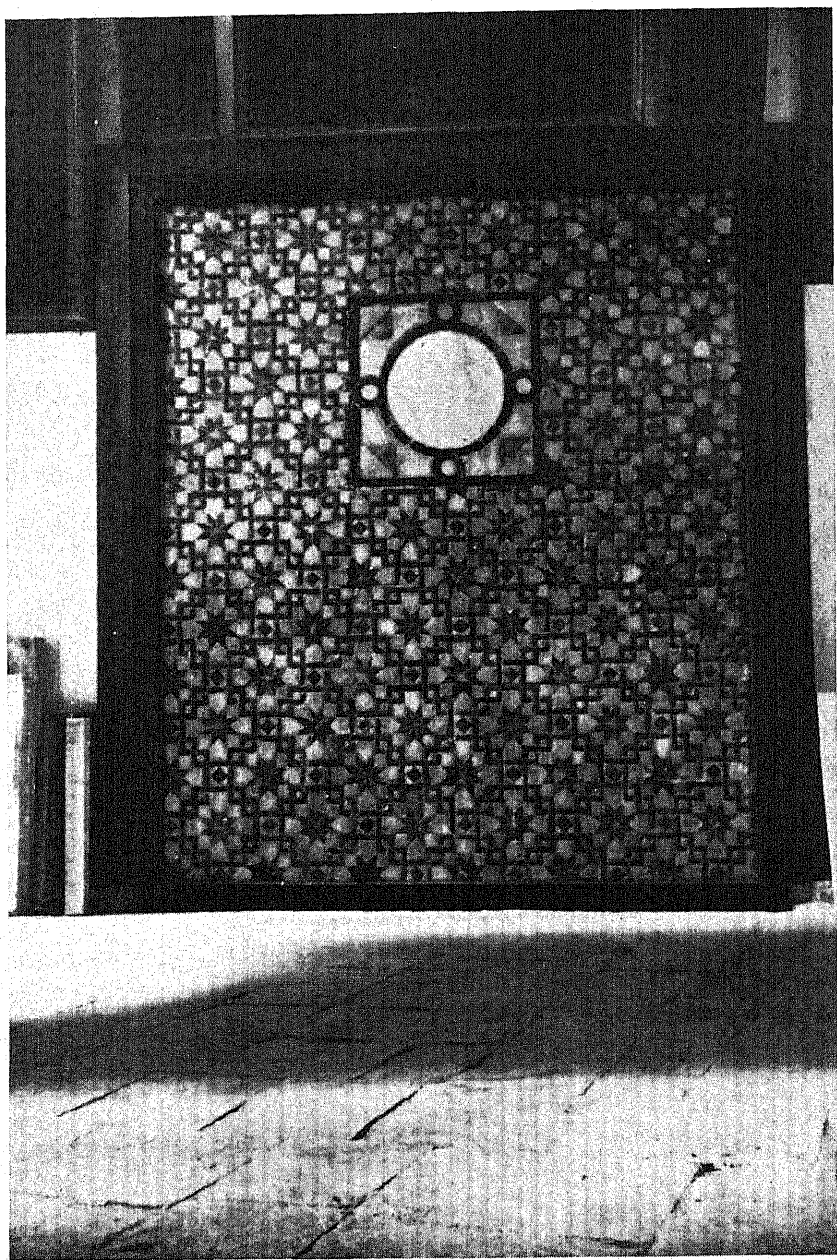
FIG. 80. PAVEMENT REMOVED FROM CHAPEL OF APPARITION

1. Chapel of the Apparition (see Fig. I, 14). The new marble slabs should be taken up, and the original mosaic reinserted. (The original is at present in the Latin gallery of the Rotunda.) (See Fig. 80.)
2. Chapel of the Franks (see Fig. I, 44) (Chapel of Our Lady of the Seven Sorrows). This original pavement requires very careful resetting, and the insertion of a few small fragments (see Fig. 81).
3. Latin Calvary Chapel (see Fig. I, 43). This pavement contains much original work, which should be reset.

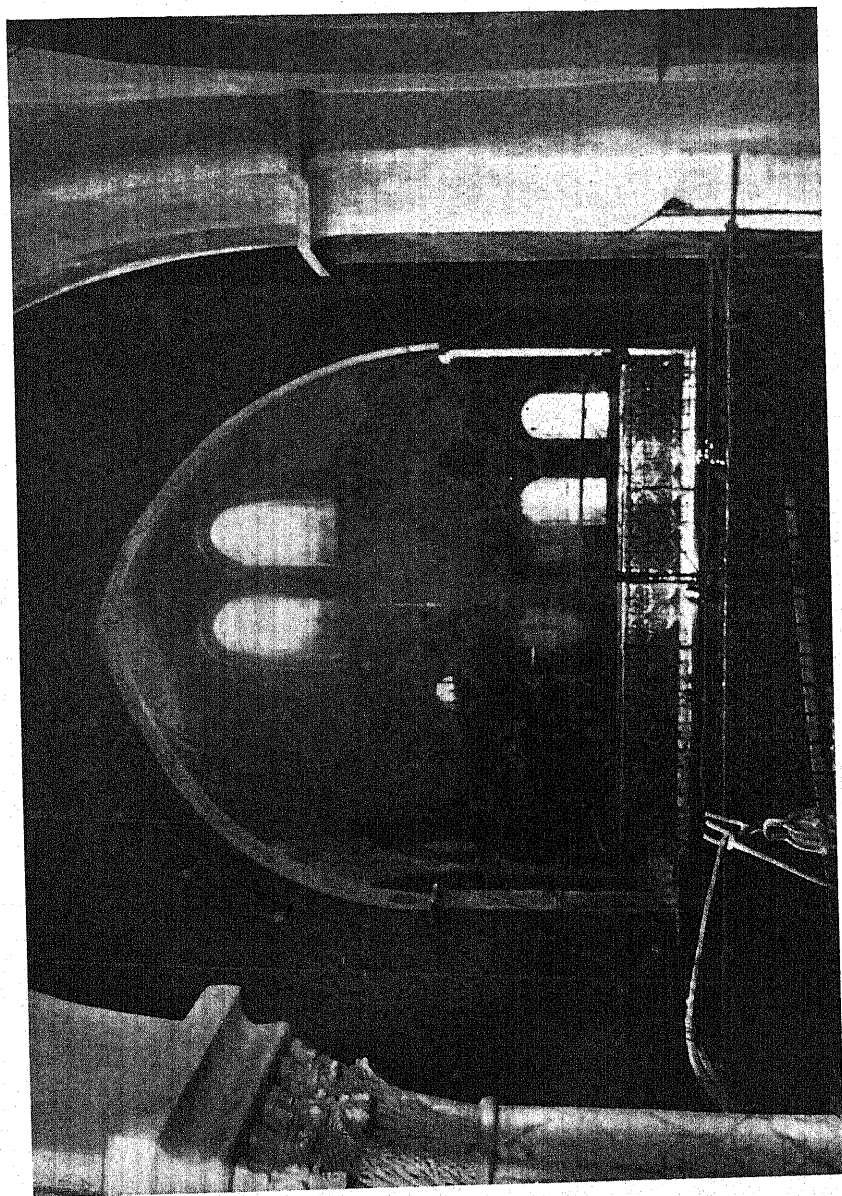
FIG. 92. SOUTH TRANSEPT, WEST ARCH

Rotunda and Armenian Sacristy from South Transept (see Fig. 92).

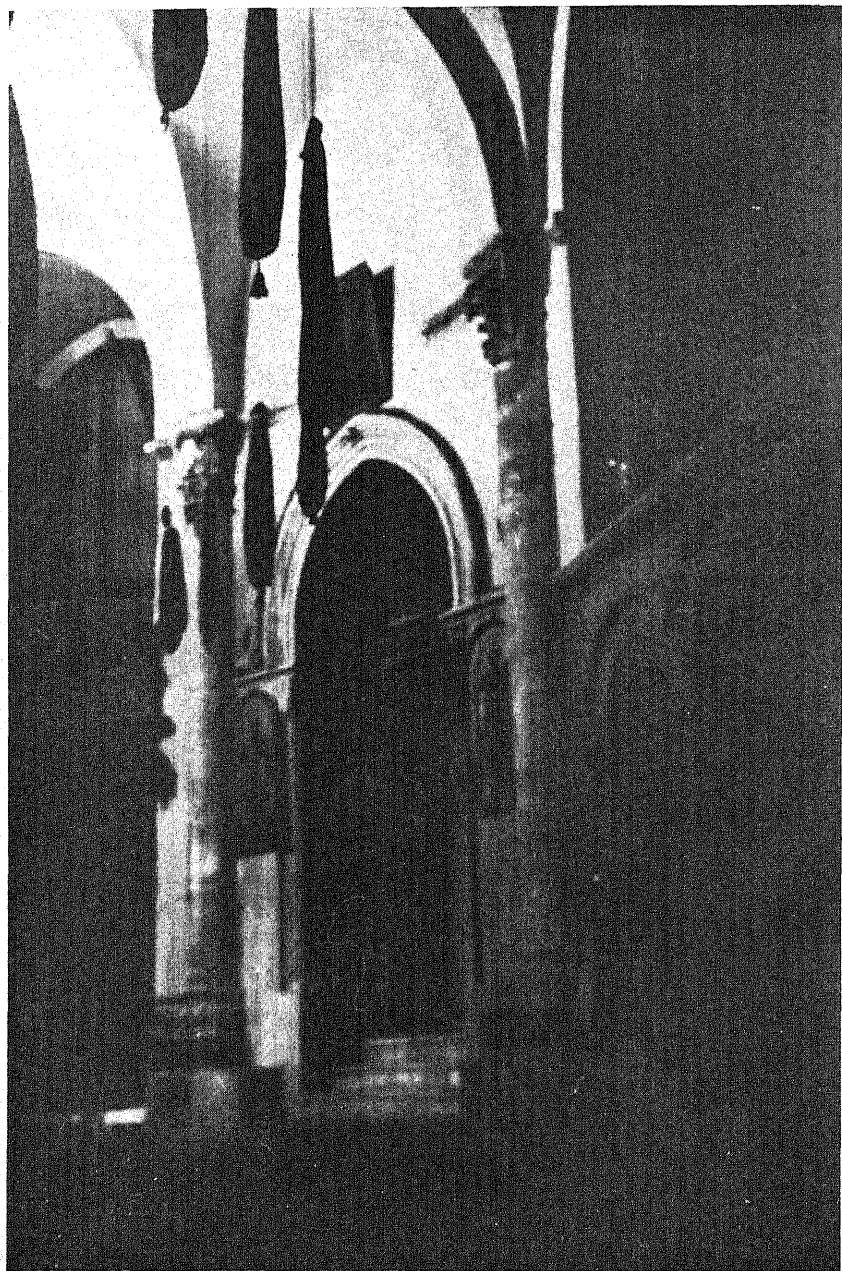
FIG. 93. SOUTH TRANSEPT FROM NORTH TRANSEPT

(9) Removal of partitions and cupboards preventing free lighting of the South Transept, through the Armenian gallery (see Figs. 93, II, 4).

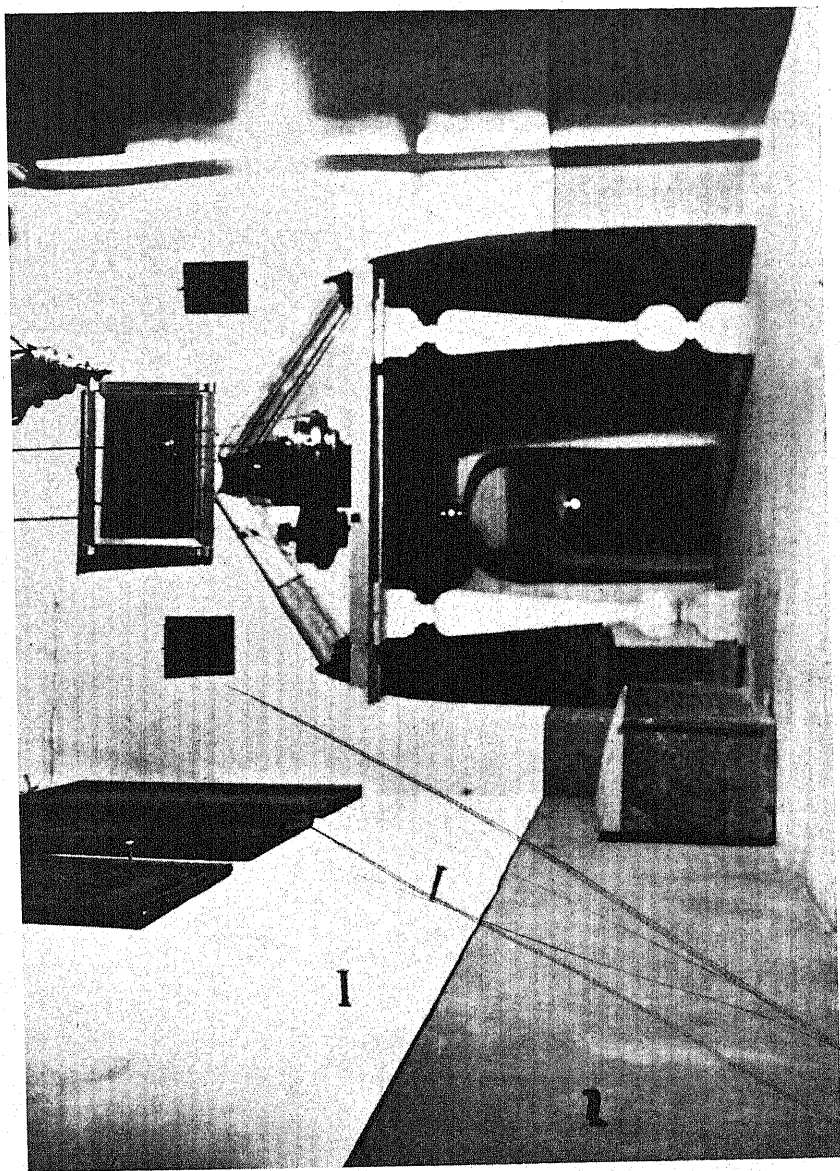
FIG. 94. AMBULATORY

(11) The reopening of the old door in the north-east of the ambulatory, as an access to the Coptic Convent, the Ninth Station, and the lane beyond (see Figs. 94, I, 30).

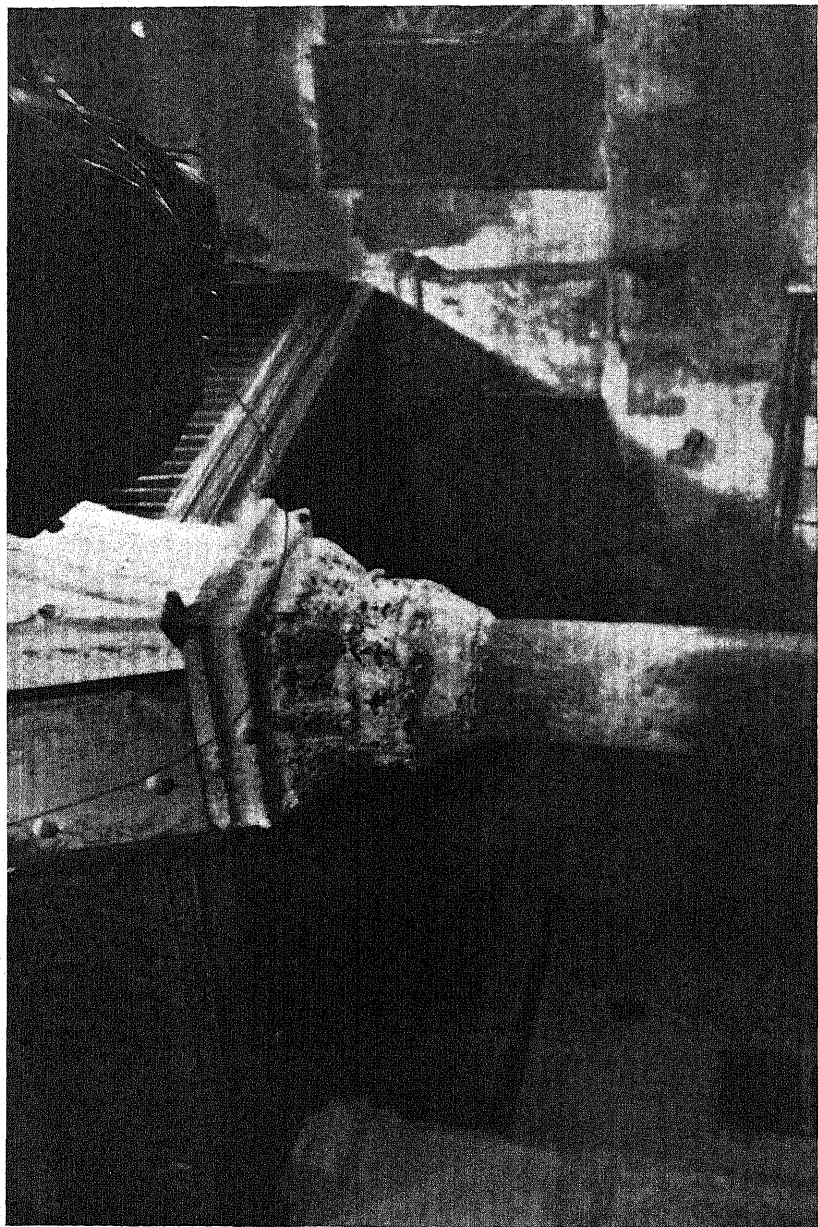
FIG. 95. PORTAL OF 1810 TO CHAPEL OF BONDS

(12) Removal of pillars and pediment built in 1810 from archway leading to the Chapel of the Bonds (see Figs. 95, I, 17).

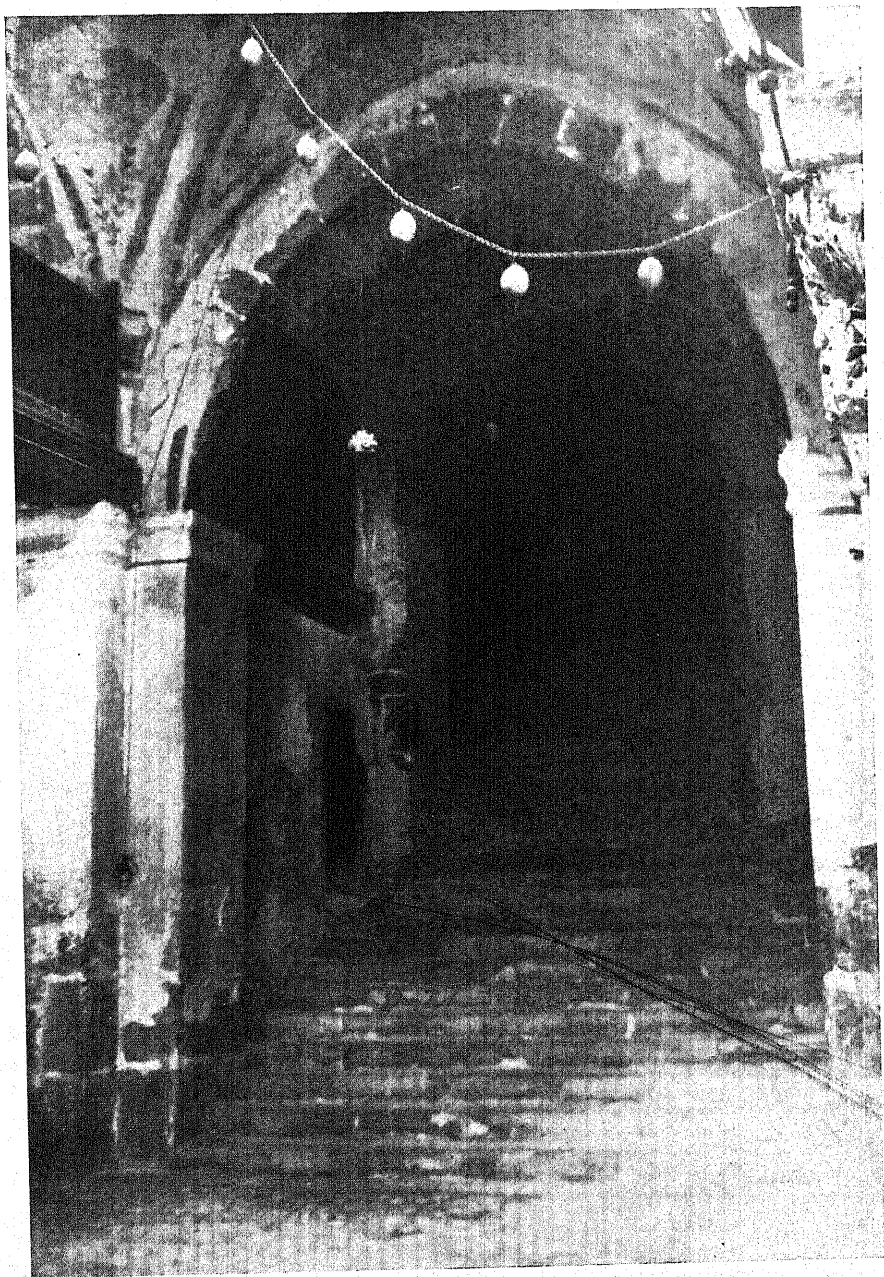
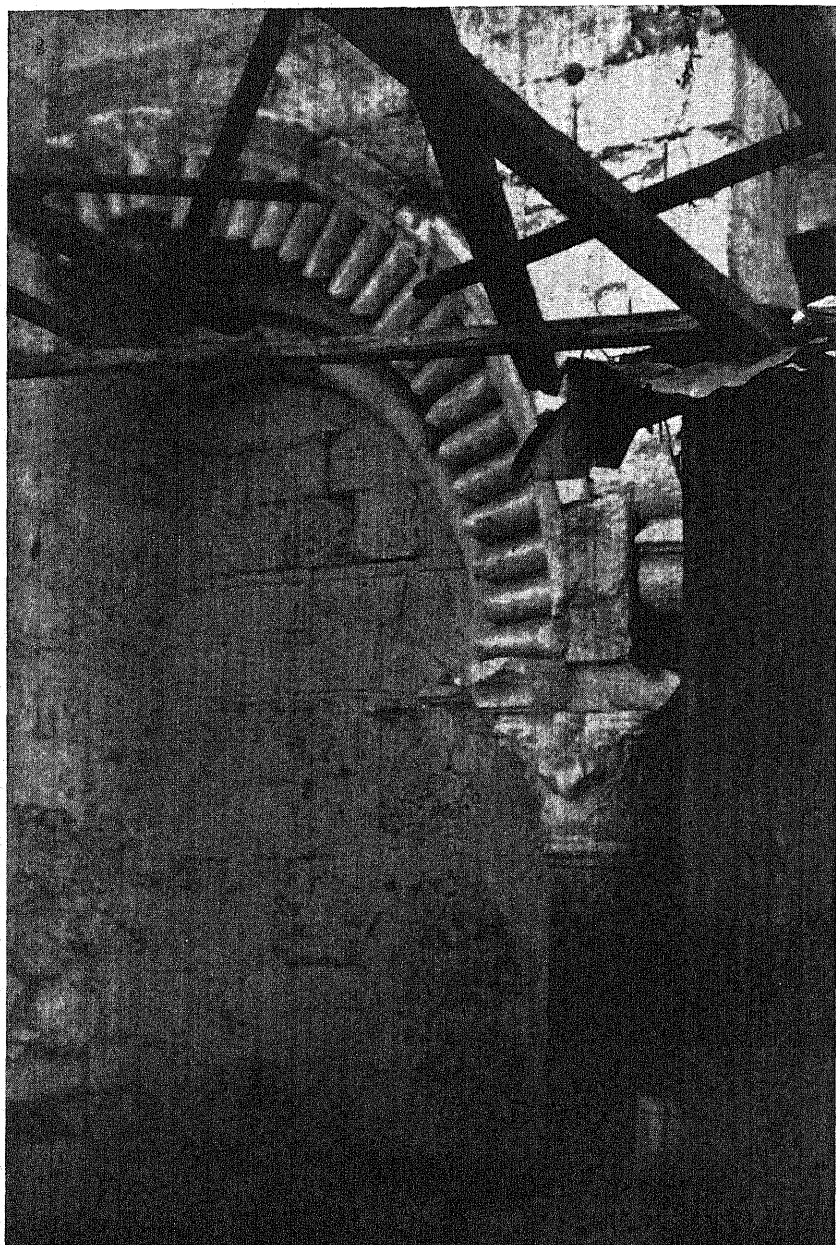
(13) Removal of the present partitions and wooden galleries from the western bays of the Chapel of St. Helena (see Figs. 96, 97, I, 28).

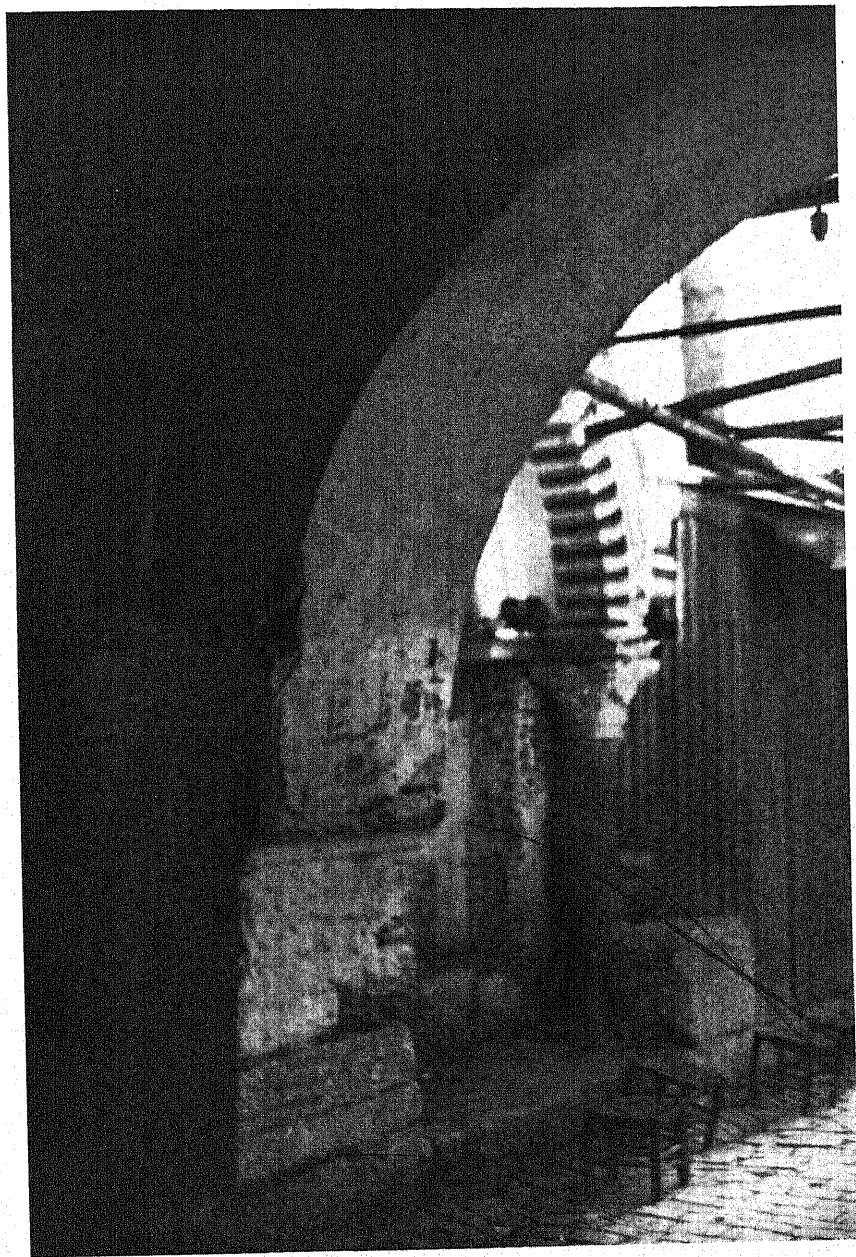
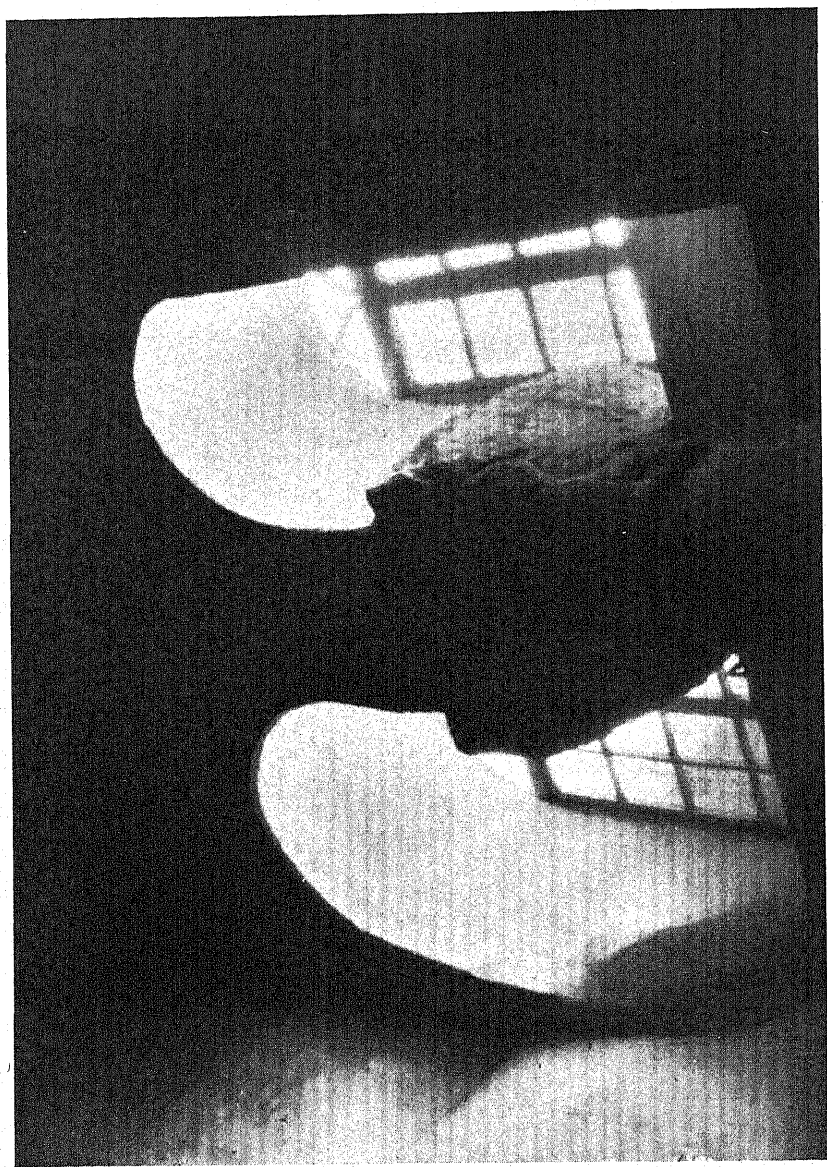
(14) Reopening of original St. Mary's Door in Christian Street, as an entrance to the Church, communicating with the passage to the North apse of the Rotunda. This would necessitate certain alterations in the piers supporting the vault over Christian Street (see Figs. 98, 99, I, 22).

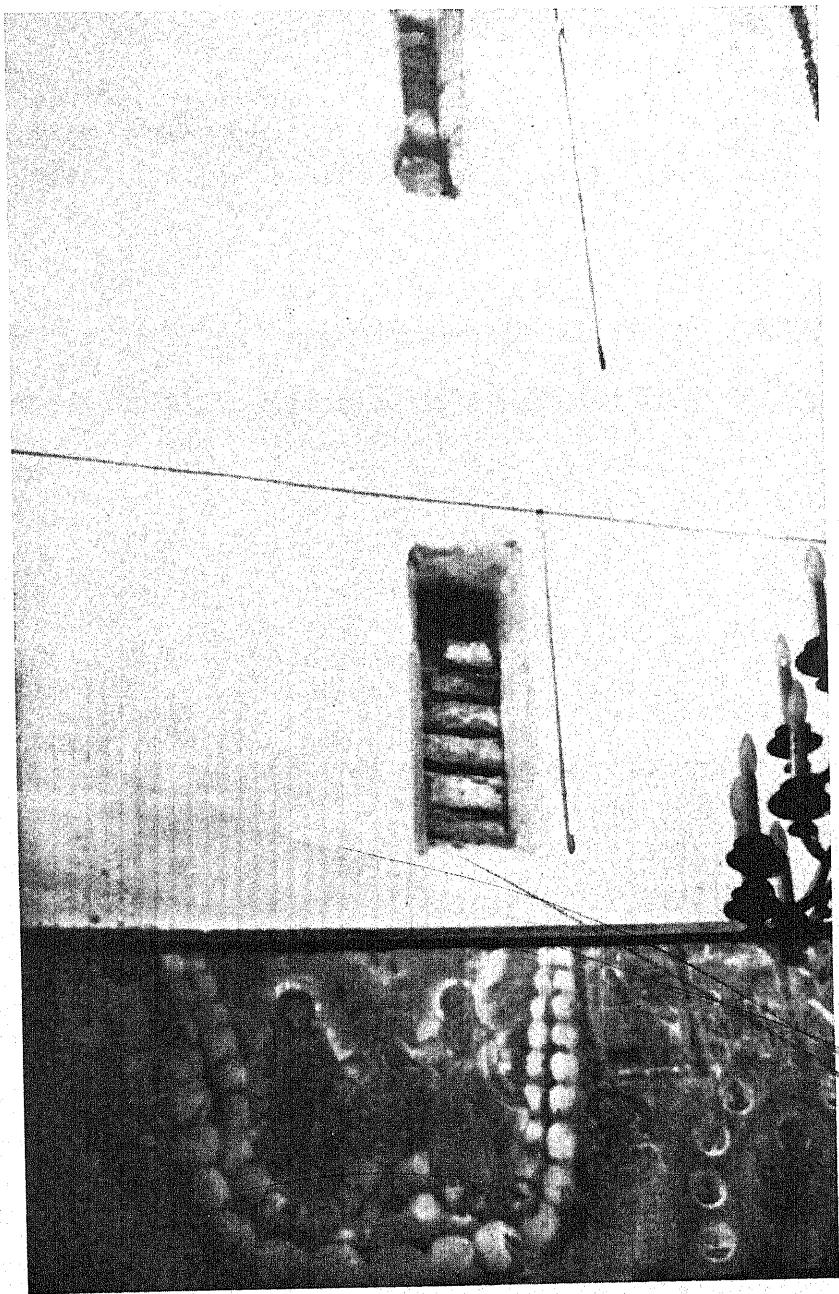
FIG. 100. BYZANTINE ARCADE IN LATIN REFECTORY

(15) Alteration of the present Latin Refectory to allow of opening of Byzantine arcade now enclosed in its western wall (see Figs. 100, I, 20).

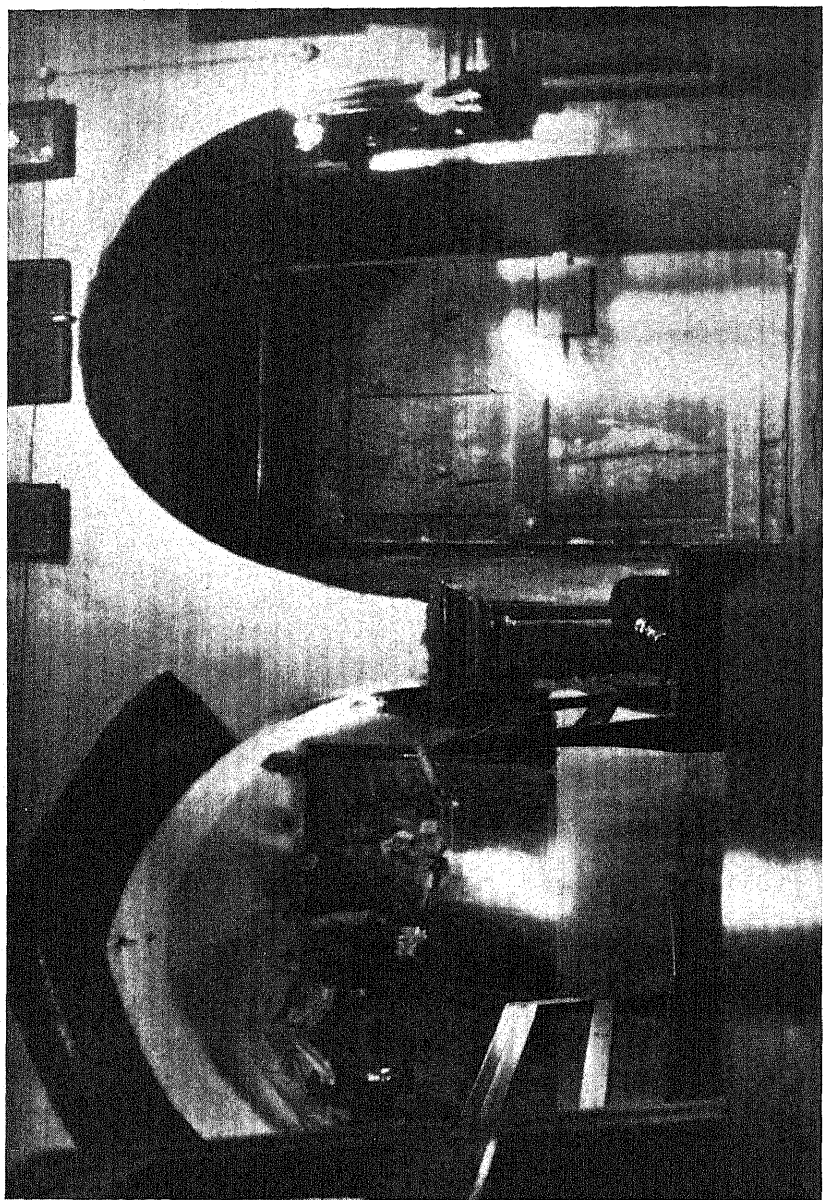
FIG. 101. WINDOWS TO STAIR IN TOWER

(16) Reopening of blocked door to spiral staircase of Tower in West wall of Chapel of the Forty Martyrs, and small windows above, to stair (see Figs. 101, I, 31).

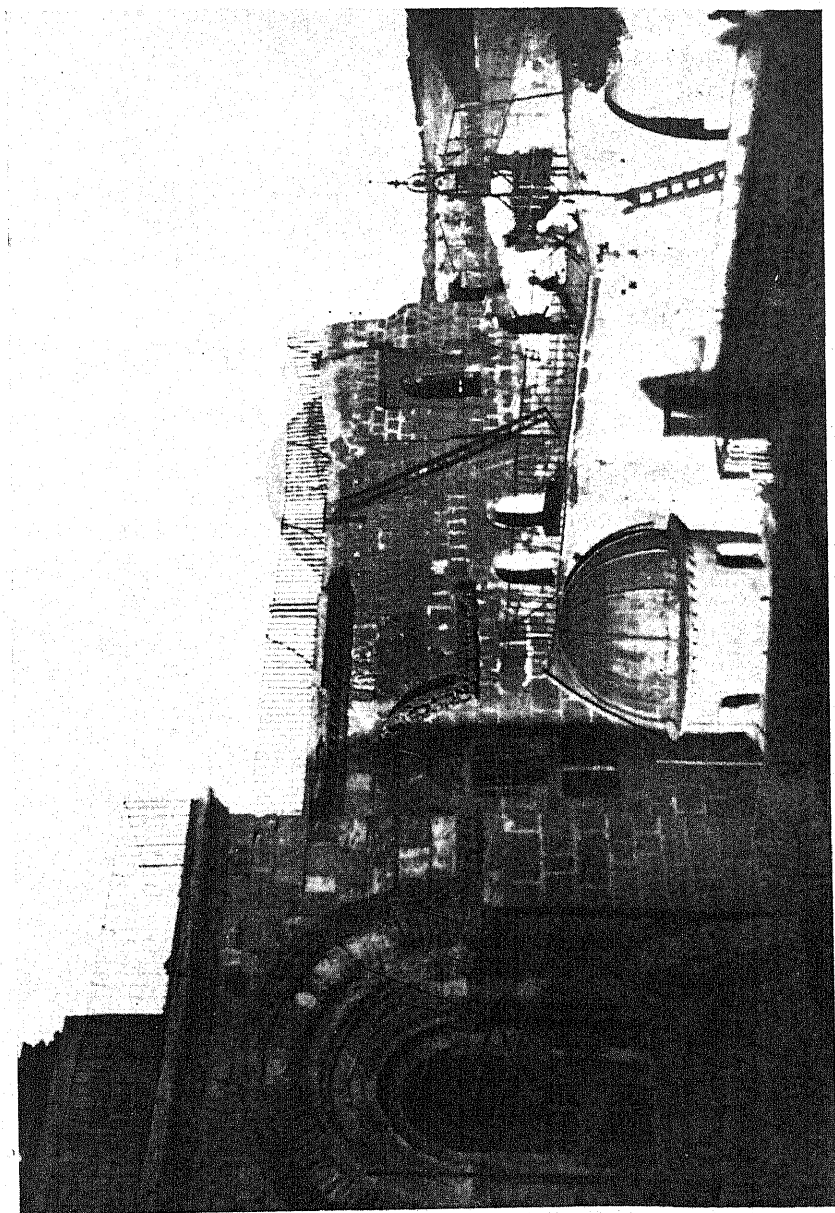
FIG. 102. WALL ARCADE. CHAPEL OF ST. JAMES

(17) Reconditioning of arcaded wall and recesses in the Chapel of St. James (at the South-west angle of the Parvis) (see Figs. 102, I, 33-V).
